**FINAL REPORT**

**Demonstration of ECDA Applicability and  
Reliability for Demanding Situations**

**DOT Prj#195**

Gas Technology Institute

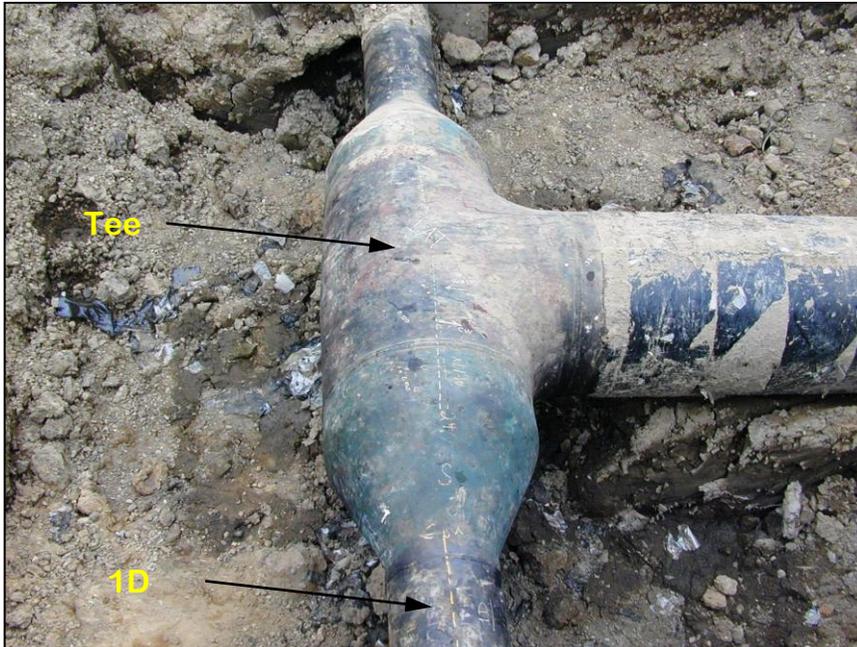
**Figure 14. The 26" diameter tee and the 12" diameter south branch (Area 1D) were Radiographic Testing (RT) inspected at the pipe bottom (6 o'clock position) for internal corrosion. No density changes consistent with the presence of localized corrosion were visible.**

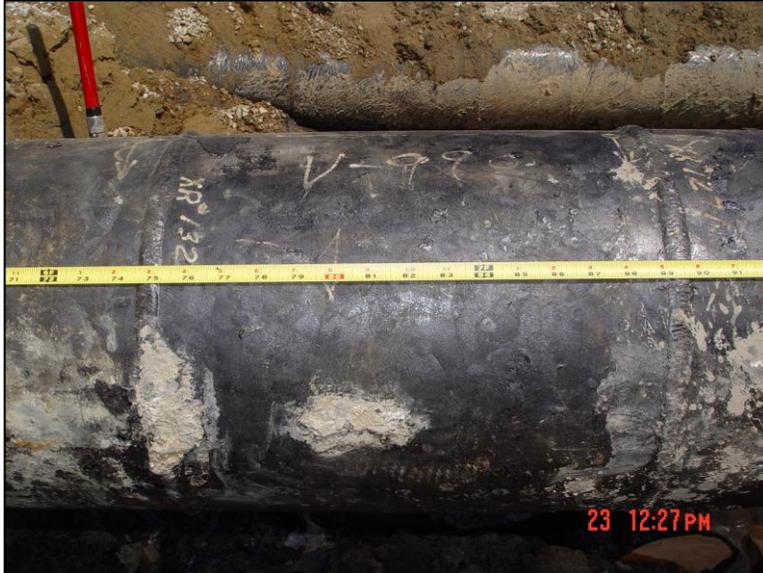
Reflections between 2A and 2B were considered minor and were due to well adhered, hard deposits and coating.

**Figure 21. Length between 2A and 2B.**

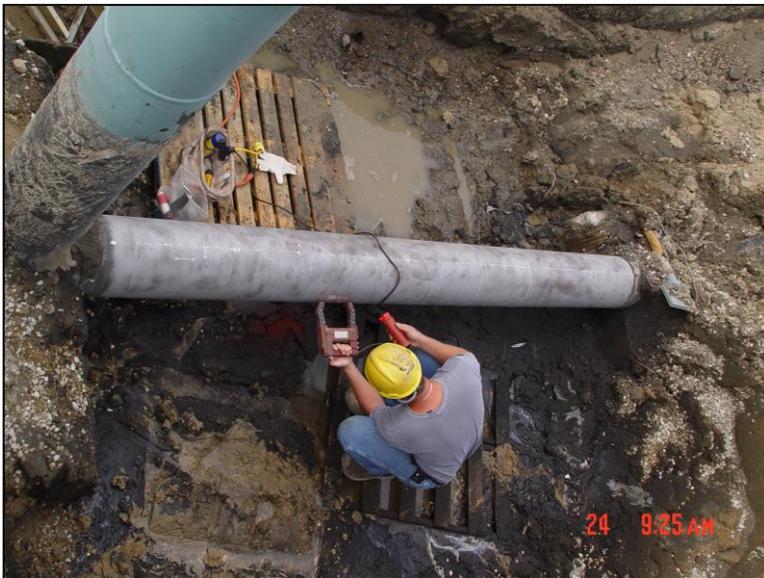
**Figure 26. Magnetic Particle Inspection found no cracks.**

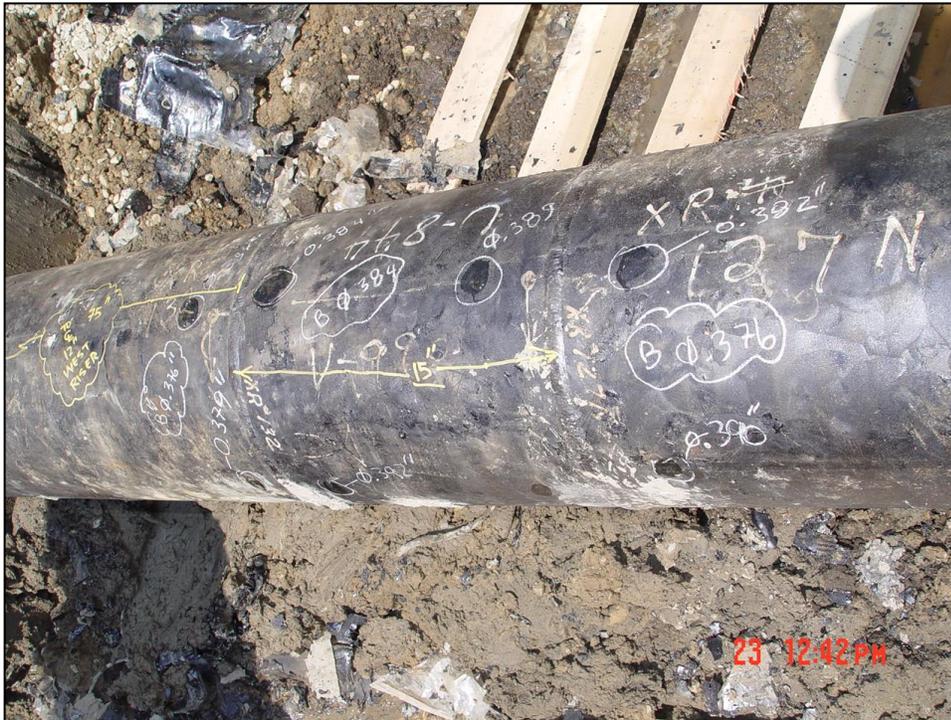
Pipe: 12" pipe is 0.375" wall, elbow is 0.420" wall. Backfill was sand. No external corrosion noted. Hard deposit noted near girth weld.

**Figure 27. Dig Site #2c (no guided wave performed here, only pipe/elbow cut out and replacement).**

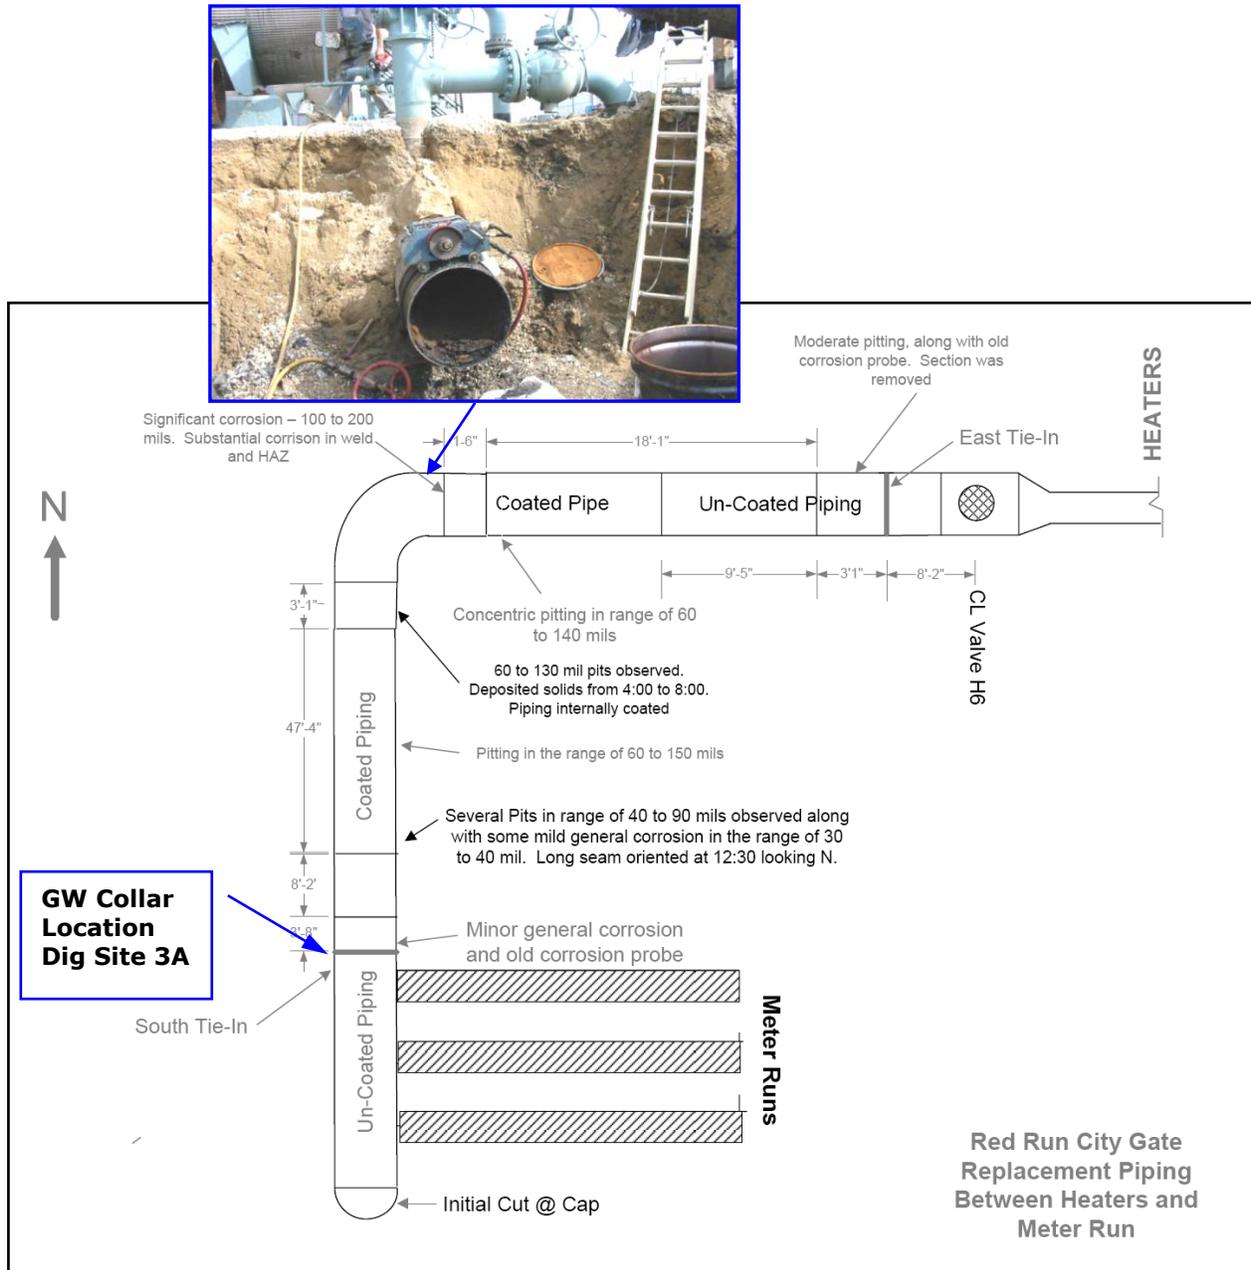
**Figure 28. This inspection and replacement was done after all the guided wave was complete. All the areas that contained corrosion were not assessed by GW (i.e., beyond detection range). The inspection at Dig Site #3A first located the presence of deposits leading to this major excavation and replacement.**

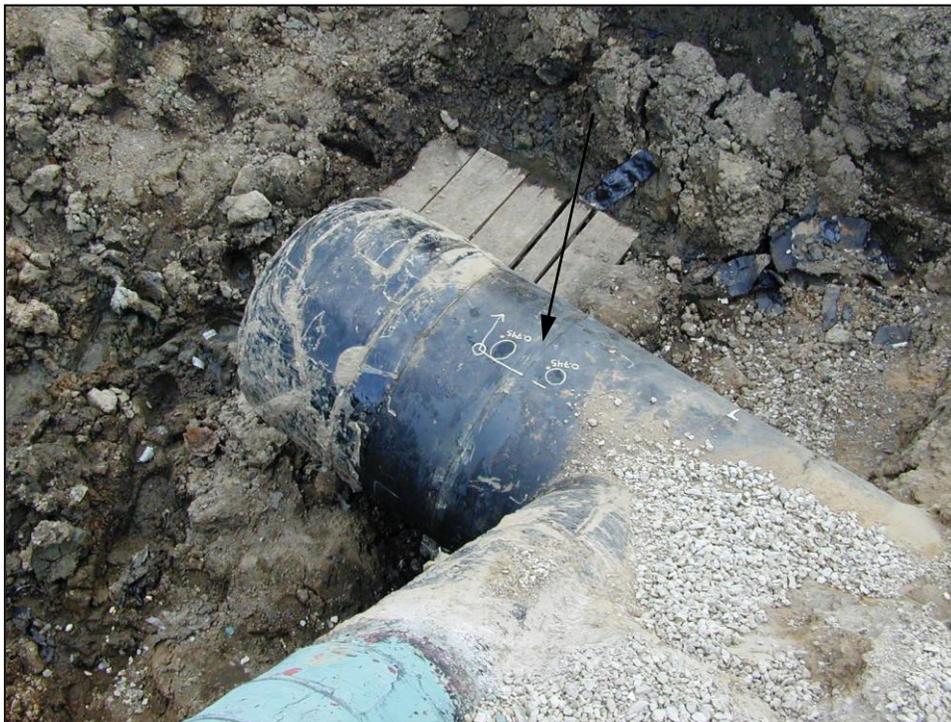
**Figure 34. Area 3B (South Stub).**

Six circumferential RT images were taken at the cap weld (yellow arrow). The 12:00 position of the weld and CW direction are noted in the photograph. No density changes consistent with the presence of localized corrosion were visible; however, internal solid material could be seen in the images and was later confirmed visually when the cap was removed.

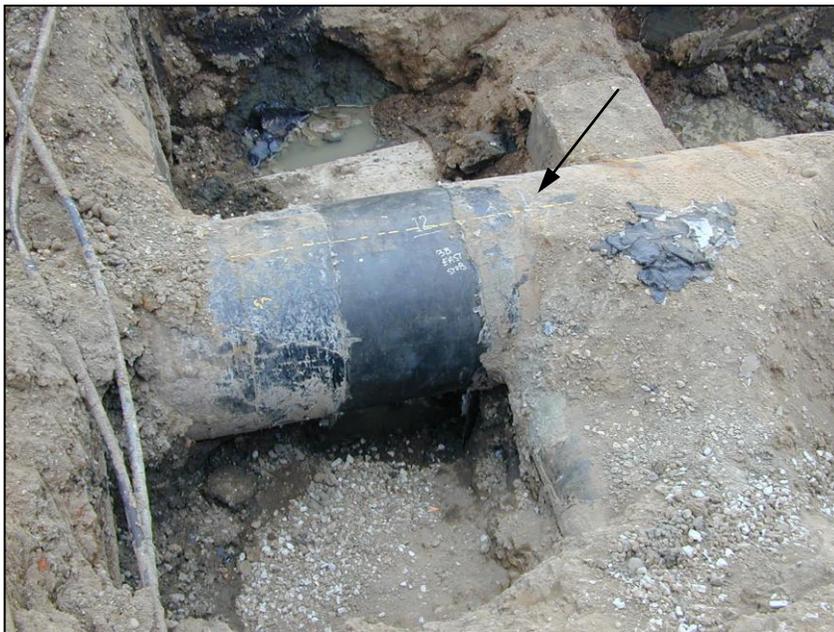
5A (southeast stub) a single RT image at the 0600 position was produced. No density changes consistent with the presence of localized corrosion were visible.

**Figure 50. Area 5A (Southeast Stub).**

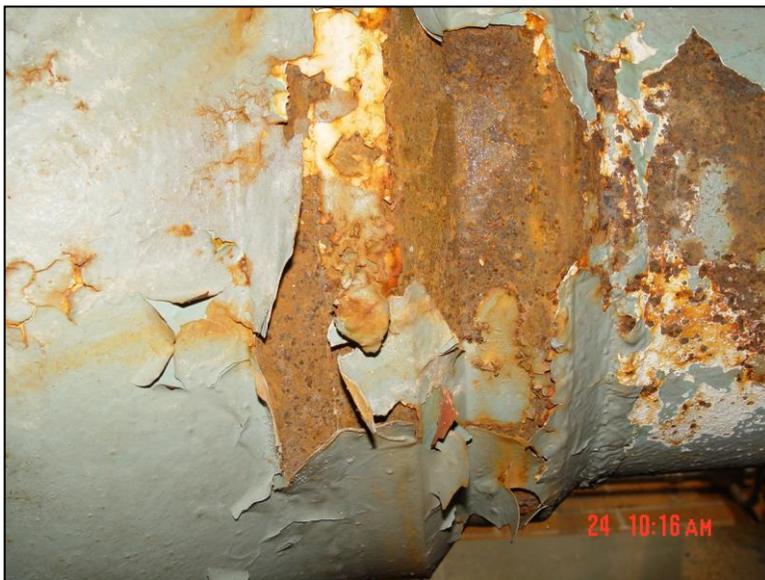
Coating: was liquid, non-epoxy based paint. Paint was peeling off bottom of low pressure side piping.

**Figure 51. Low pressure side (5C) of North Regulator Run.**

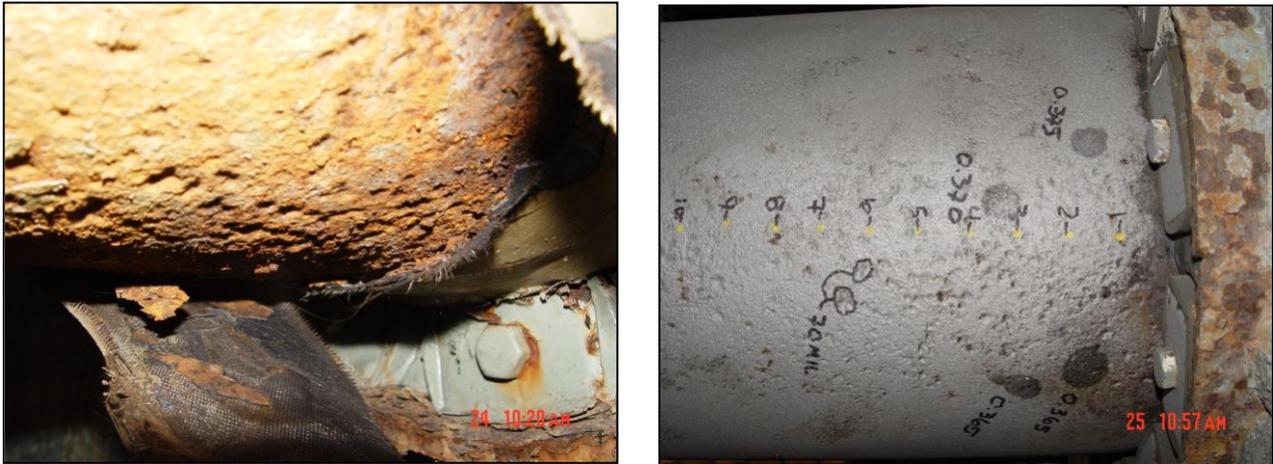
- ASME B-31-G mod. was performed and indicted the piping safe to remain in place. This area is adjacent to the wall and has a casing with link seal thru the penetration.
- Data obtained from defect assessment on the basement side as discussed in the previous bullets was used to provide calibration of GUL unit allowing evaluation of waveforms within the casing. Corrosion in the casing was no more severe than that found in the basement and piping was safe to remain in place.

**Figure 52. Significant External Corrosion under coating along 5C run before grit blasting (left image) and after grit blasting (right image).**

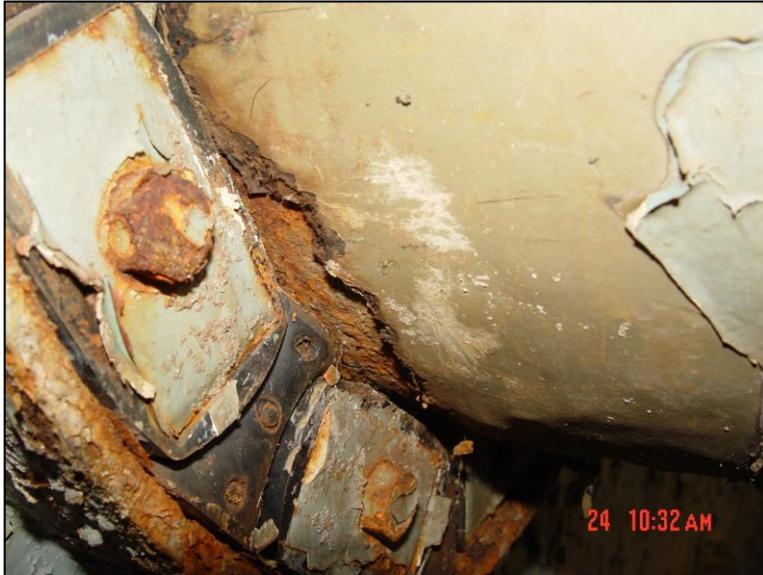
Coating: was liquid, non-epoxy based paint. Paint was peeling off bottom of low pressure side piping. Significant external corrosion noted at wall penetration of 6B at the 6:00 position.

**Figure 60. Low pressure side (6B) of South Regulator Run.**

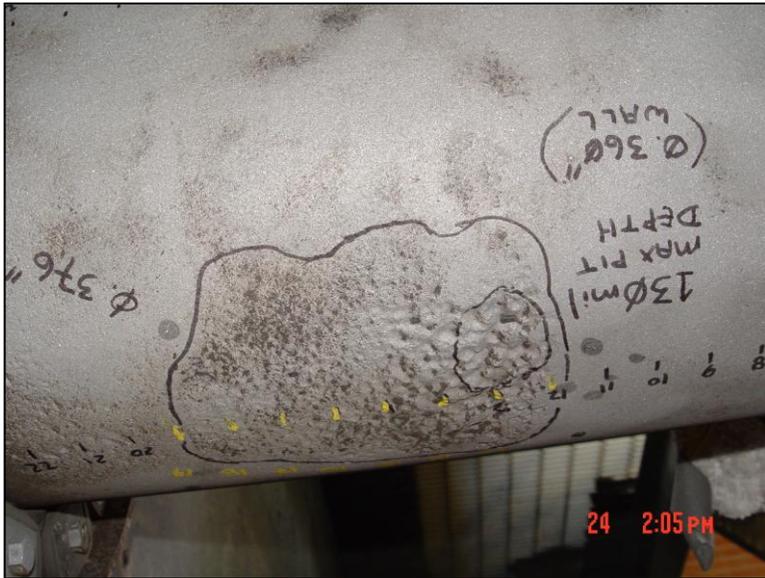
evaluation of waveforms within the casing. Corrosion in the casing was no more severe than that found in the basement and piping was safe to remain in place.

**Figure 61. Significant External Corrosion under coating along 6B run.**

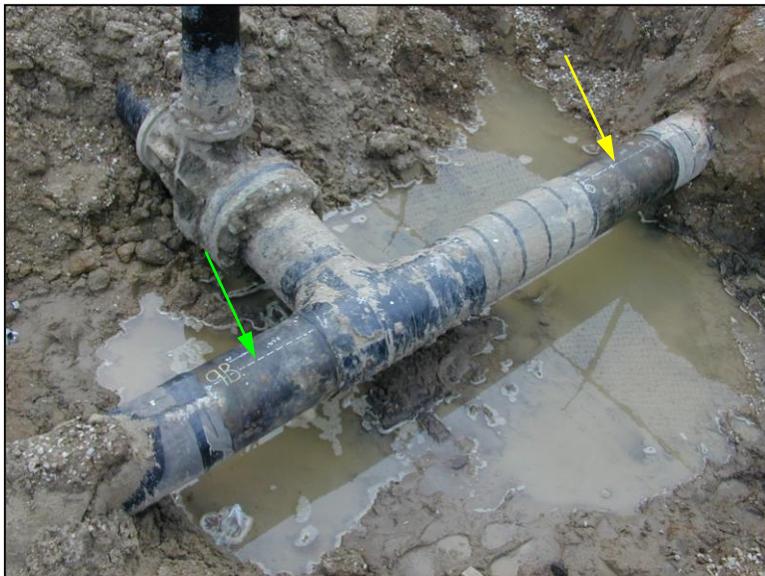
**Figure 78. Areas 9A and 9B.**

A single RT image at the 06:00 position was produced for pipe at Areas 9A (yellow arrow) and 9B (green arrow) on both sides of the tee. No density changes consistent with the presence of localized corrosion were visible. View is looking southwest.

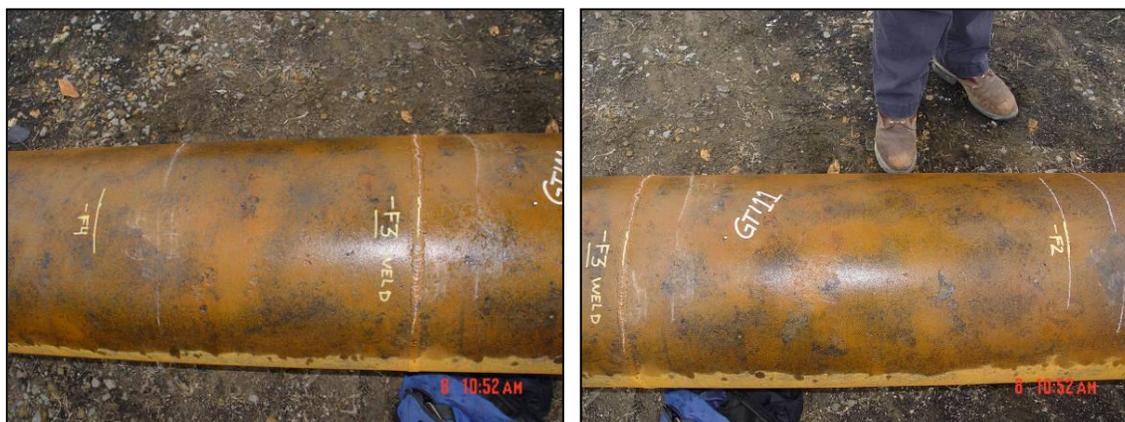
- (-F2) The area 5 ft to the east of the ring, on the north side (about 250 degrees) was below call out level and due to mineral deposits, no corrosion was found during direct exam.
- (-F3) Assumed weld was confirmed upon excavation.
- (-F4) Assumed feature due to deposit (not corrosion) confirmed.

**Figure 105. Dig site #0: -F4, -F3, & -F2 locations.**

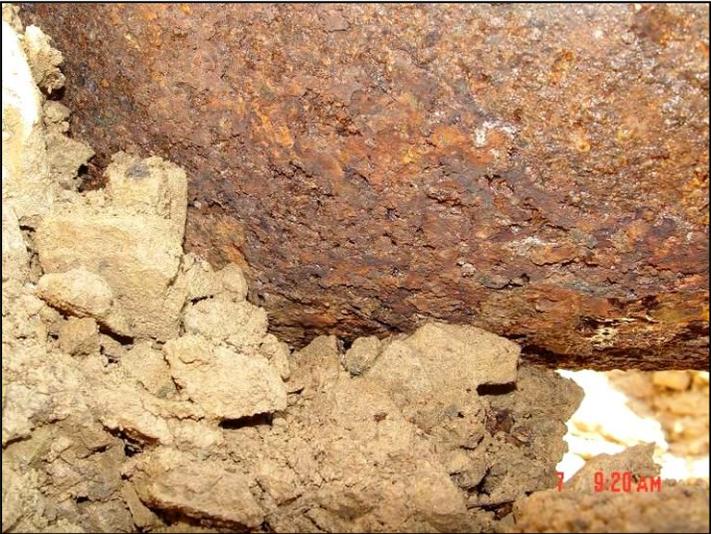
- (+F2) Cat 2 strong reflection along bottom of pipe was confirmed as leafing corrosion along the bottom of pipe that extended into the earth to the West (all along the 6 o'clock position), see picture below.

Figure 111. Dig site #1: Location just East of +F2, corrosion continued to the West as the earth was dug back.

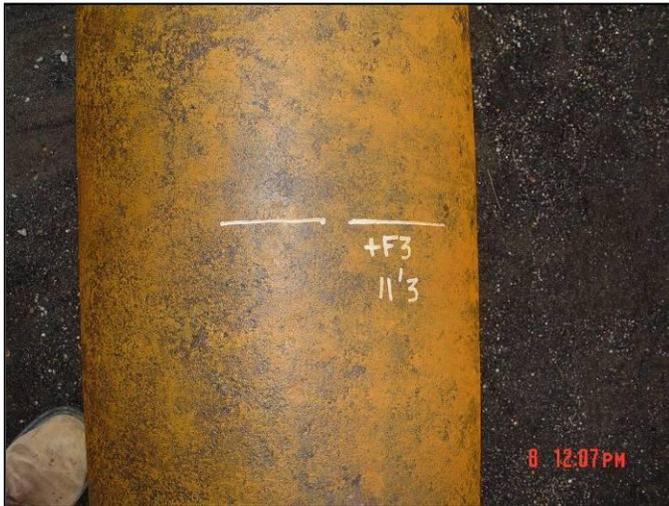
- (+F3) Cat 1 possible deposits. No corrosion was found only deposits before cleaning.

**Figure 112. Picture of pipe at location of +F3 - no corrosion was found only deposits before cleaning.**

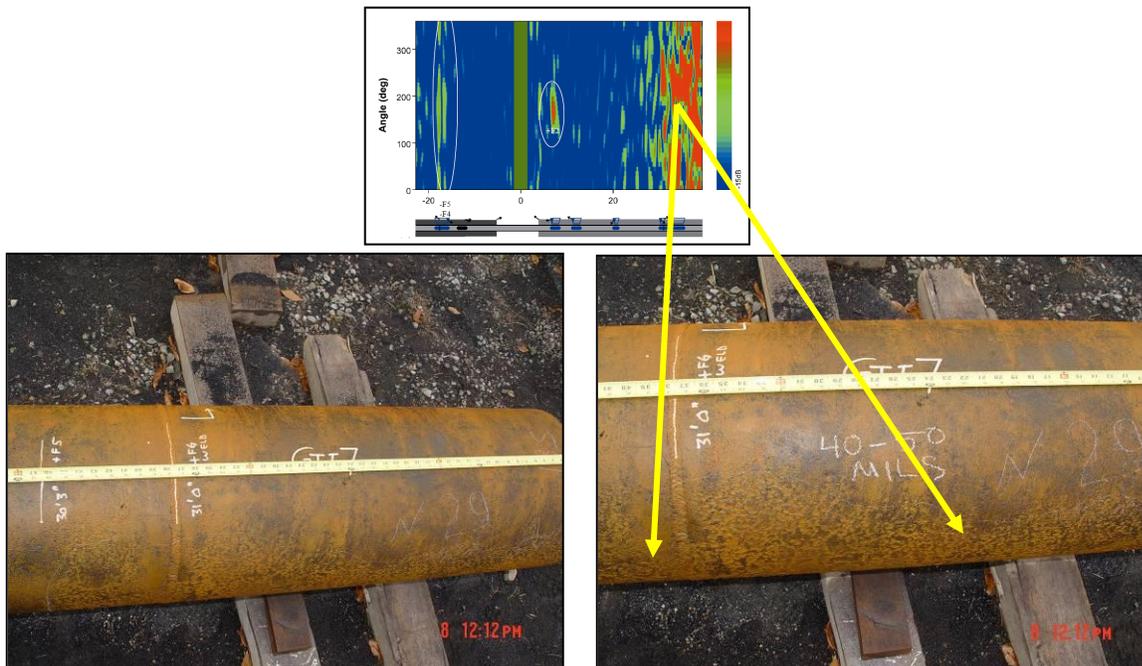
- (+F5) Cat 2 feature just West of weld (+F6) corresponded to large area of 40-50 mil deep pitting along bottom the pipe, see pictures below. This area corresponds to the red features in the C-Scan.

**Figure 113. Picture of (+F5) Cat 2 feature just West of weld (+F6) corresponded to large area of 40-50 mil deep pitting along bottom the pipe, see pictures below. This area corresponds to the red features in the C-Scan.**

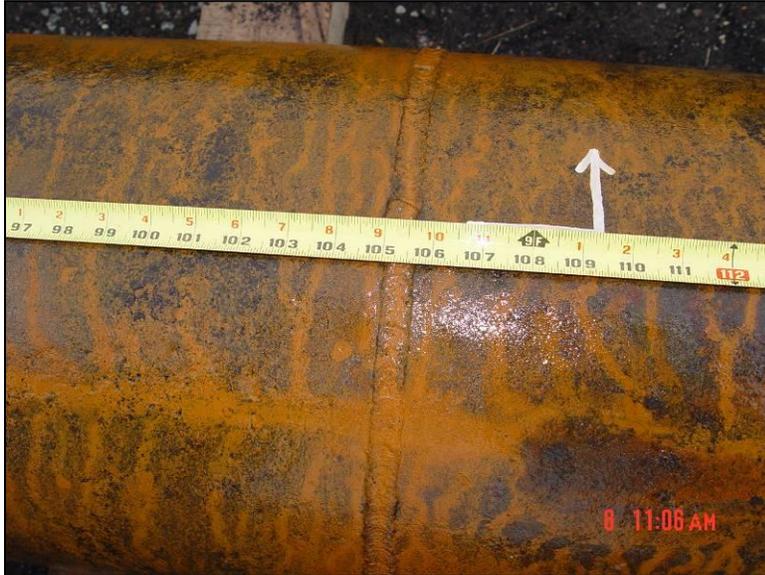
- (-F4 & -F5) Called out as a weld with possible mitre bend/joint. Confirmed as marginal weld with the following defects (inadequate penetration, burn through, slag inclusions and lines, external undercut, porosity, gas pockets, and concave crowns).

**Figure 114. Picture of -F4/-F5 showing weld confirmed by radiography to have multiple defects.**

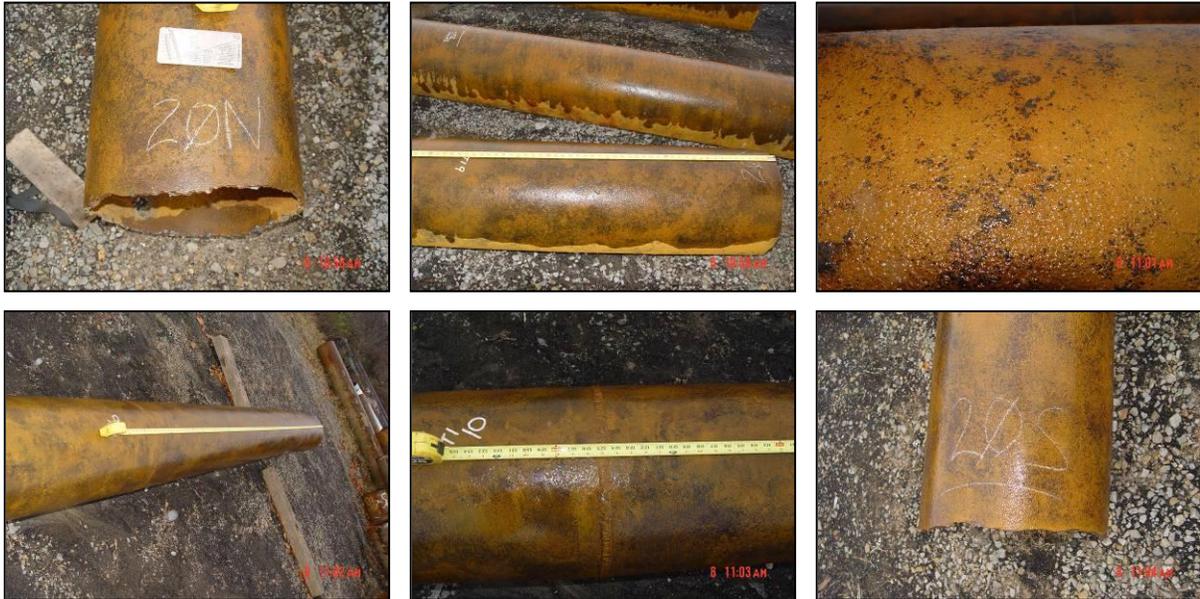
A set of pictures for the pipe segment that contained anomalies #27 & #28 are shown below. No significant corrosion was found.

**Figure 129. Pipe joint '20' conditions. No defects were observed on direct exam and during UT direct wall measurements.**

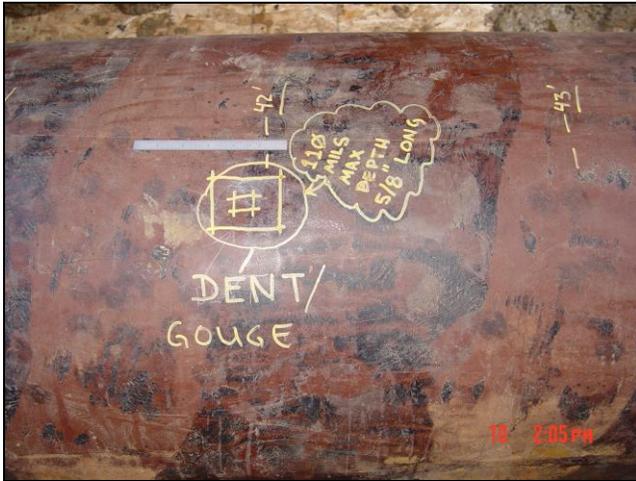
Figure 150. Dent with no corrosion observed at +42ft reference. Notice the good prime coat adherence.

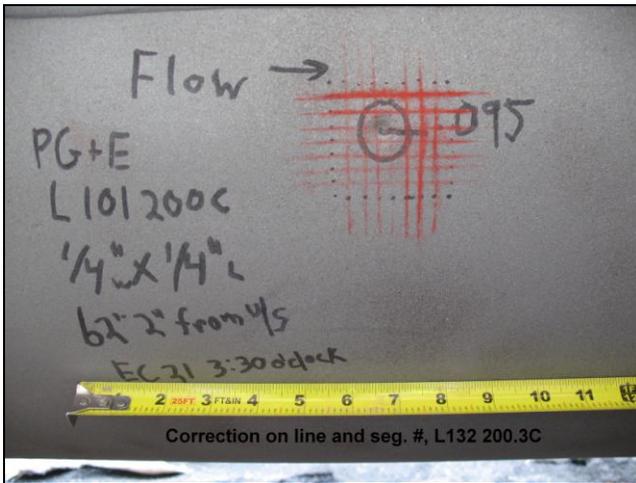
Figure 151. After sand blasting, dent classified to be "corrosion" at its center by third party, however there was no evidence of "corrosion" when visually examined.

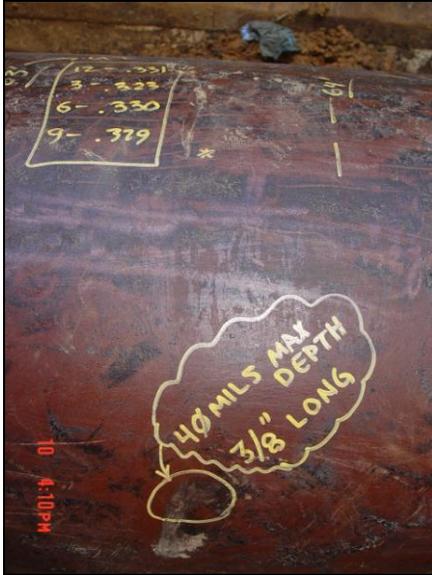
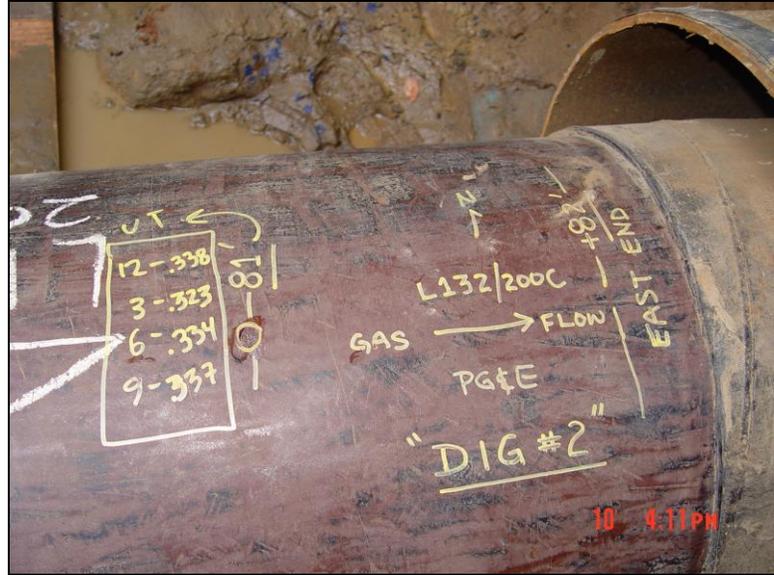
(a) Corrosion observed at reference +69 ft (west to east +), (b) East end at casing showing wall thicknesses.

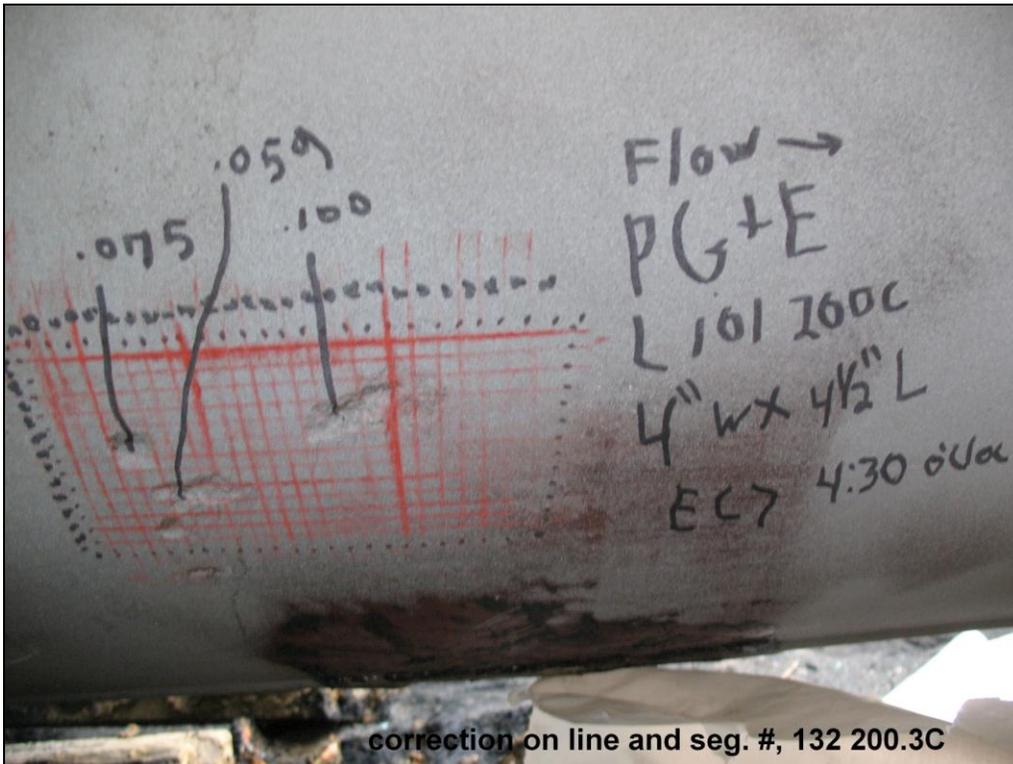
Figure 154. Sand blasted surface with grid markings and maximum depths at +69 ft (the grid map for these features is shown in the next Figure).
